**Exide Frankfort IN  
555 North Hoke Avenue, Indiana**

As a follow-up to the Technical Memo regarding site water runoff, a local paving contractor was contracted to seal the cracks and install a rolled asphalt curb in the infiltration gallery area to mitigate future potential run off from this area. The photos were taken August 13, 2025.

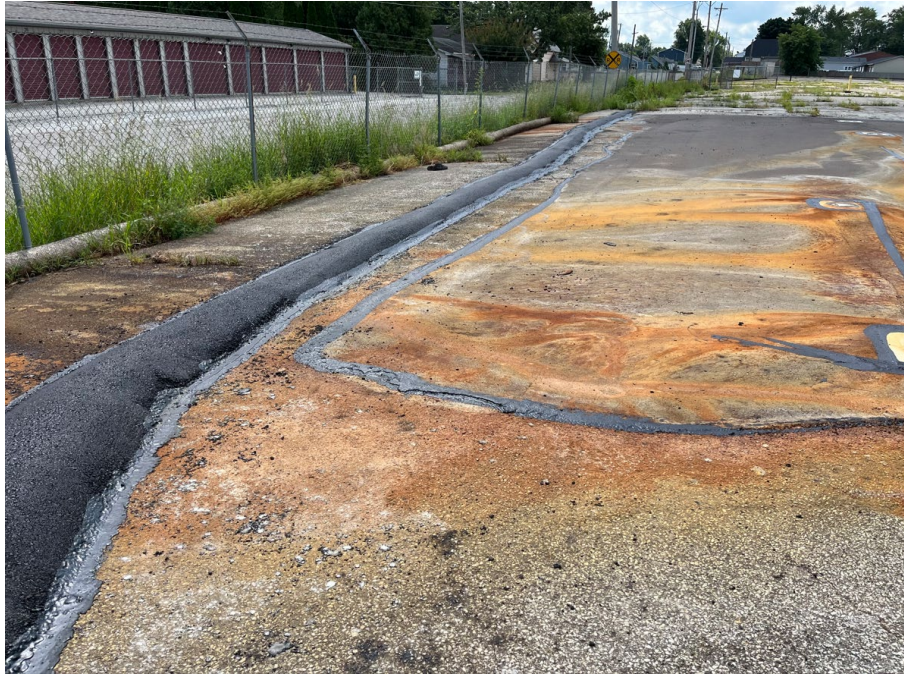
Photograph 1 – New 6-inch curb installed adjacent to east side of infiltration gallery

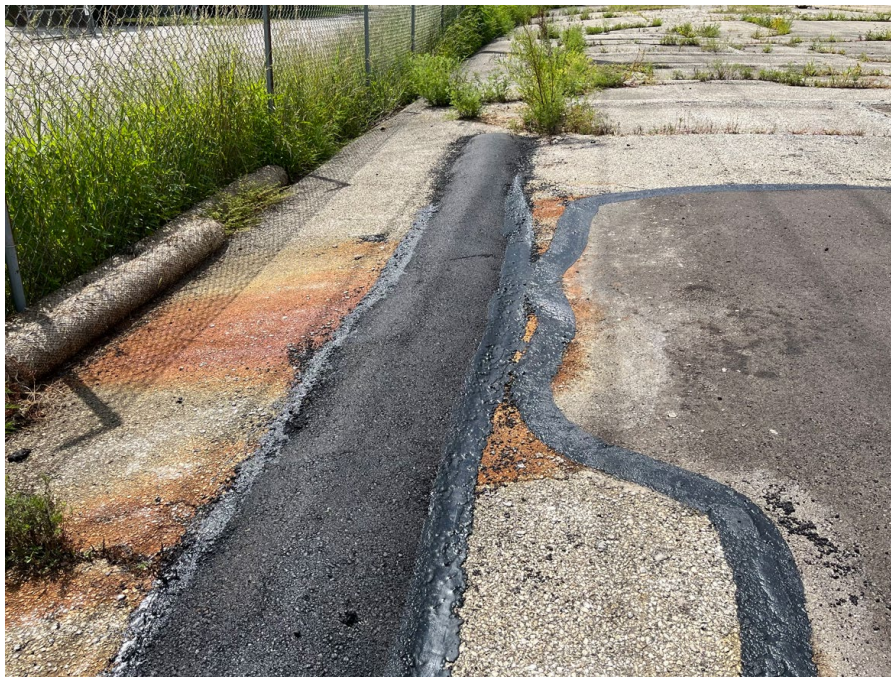
Photograph 2 – Southern end of curb – note crack sealing

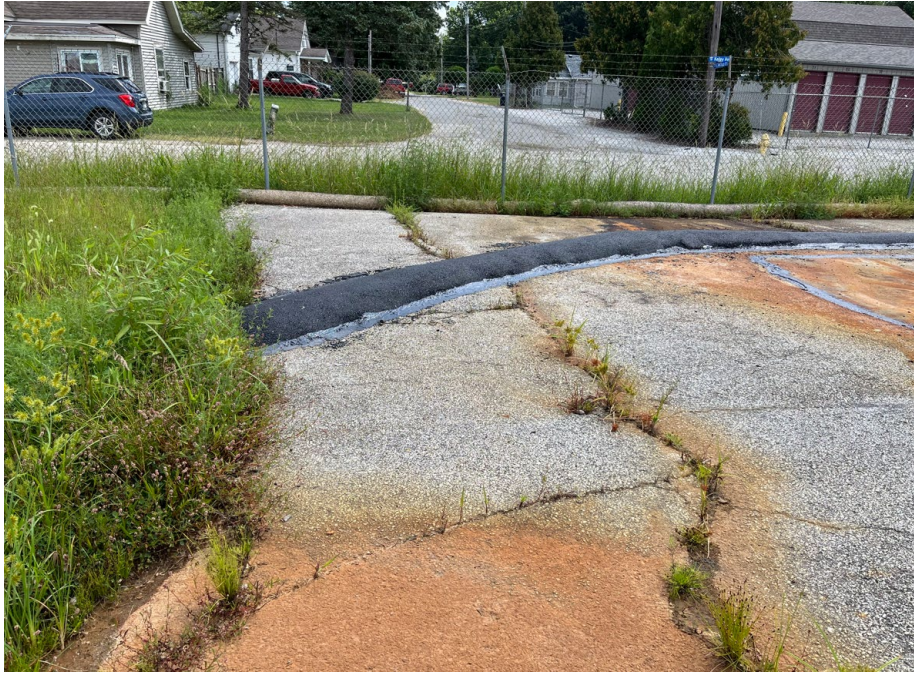
Photograph 3 – Northern end of 6-inch curb

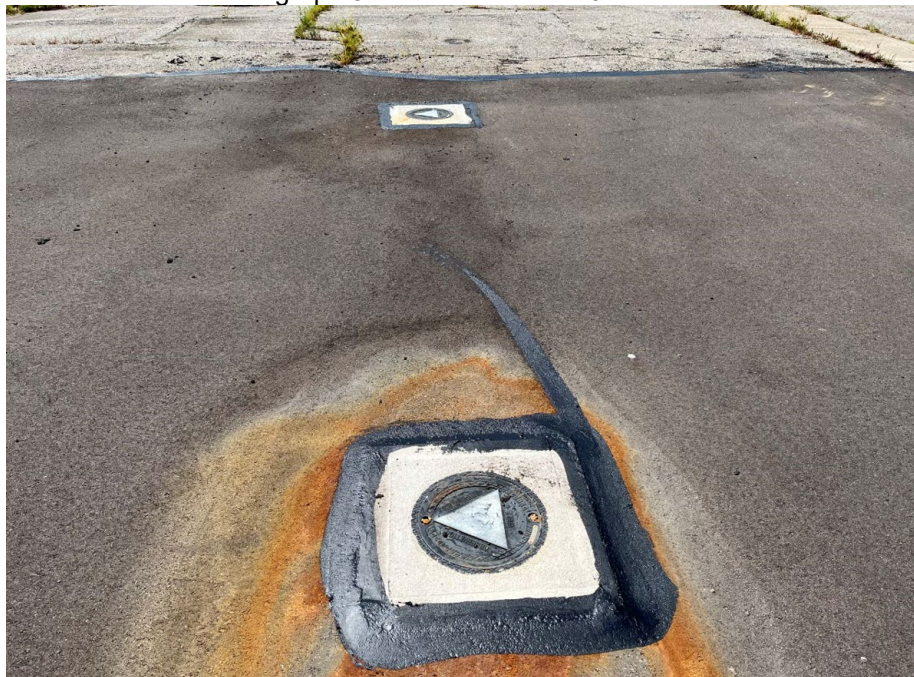
Photograph 4 – Crack sealing

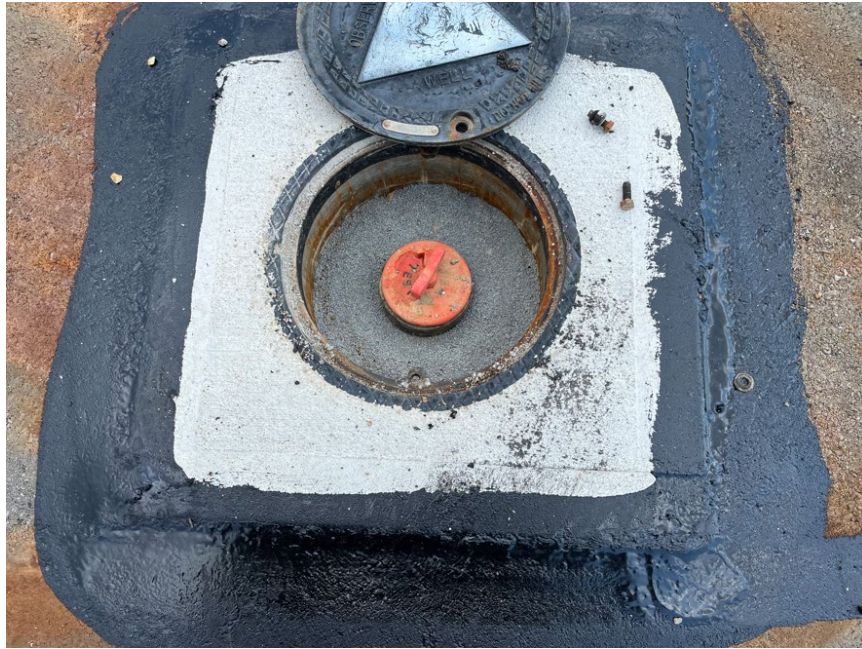
Photograph 5 – Infiltration gallery injection point with bentonite seal.
