CURRENT CONDITIONS REPORT

EXIDE TECHNOLOGIES
555 North Hoke Avenue
Frankfort, Indiana
EPA ID No. IND001647460

**ADVANCED GEOSERVICES CORP.
West Chester, Pennsylvania**

**Project No. 2011-2678-00
July 6, 2017**

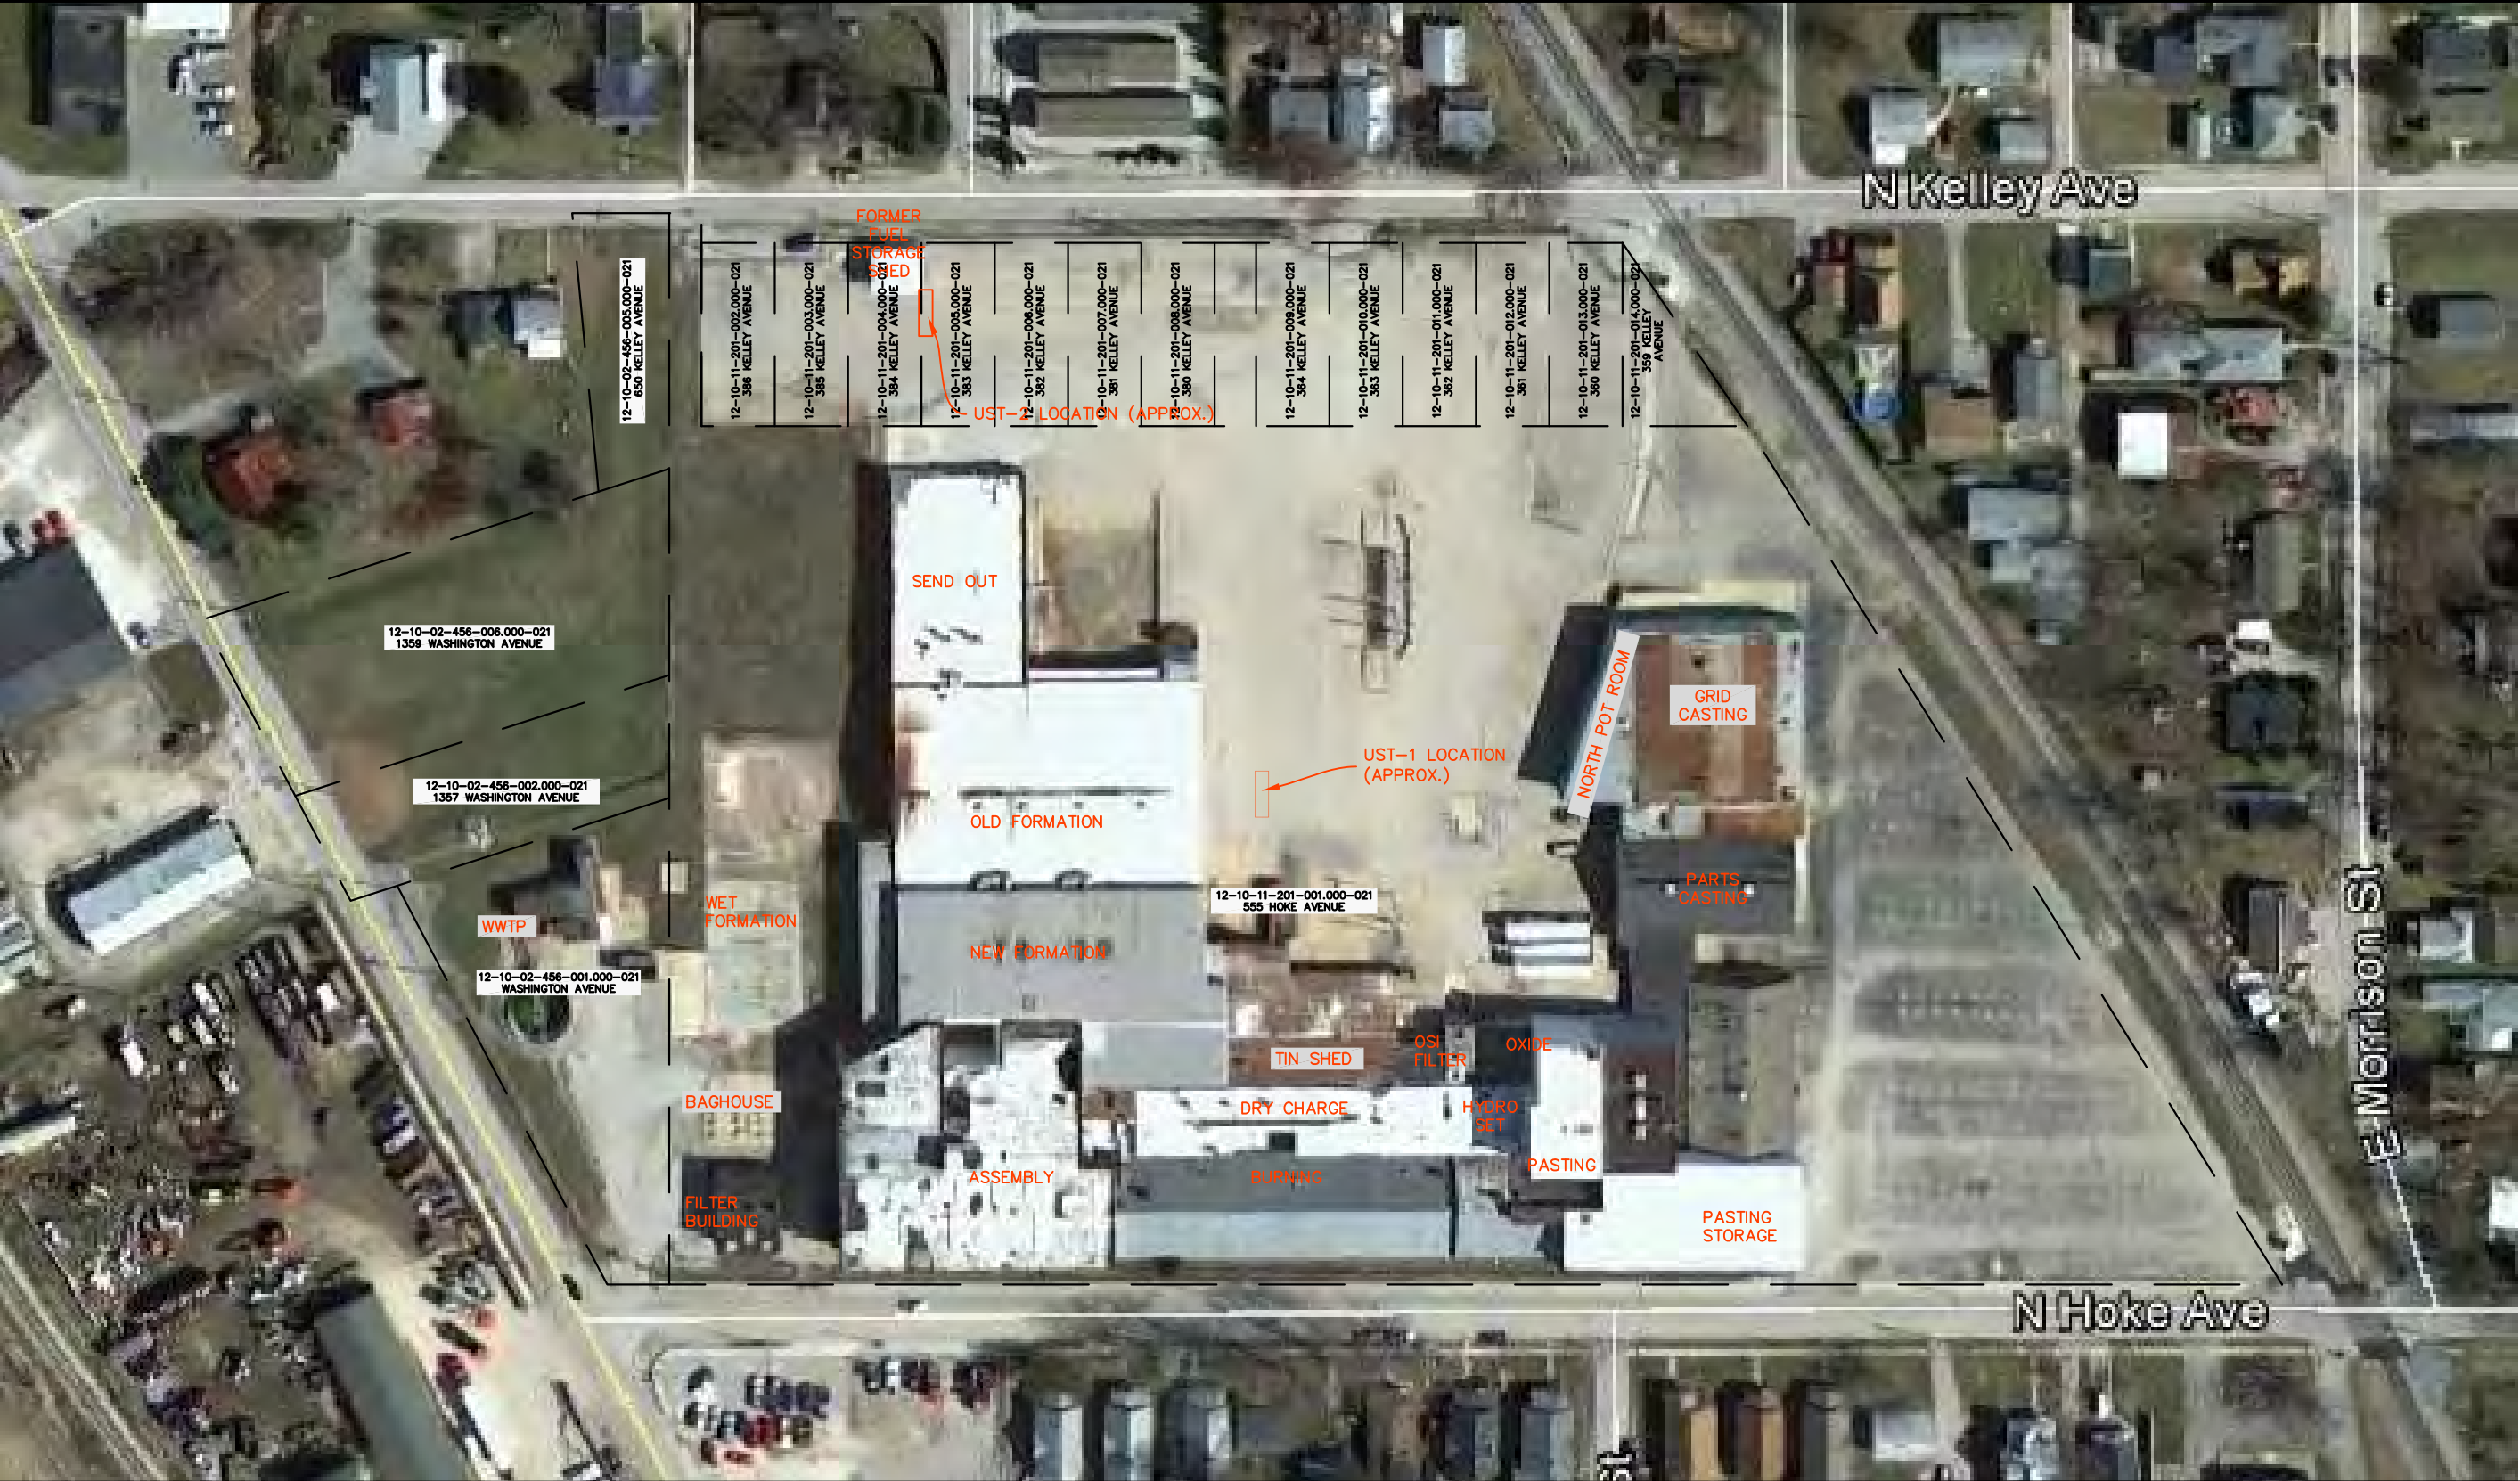
FIGURE 2

PRE-DEMOLITION CONDITIONS
2012

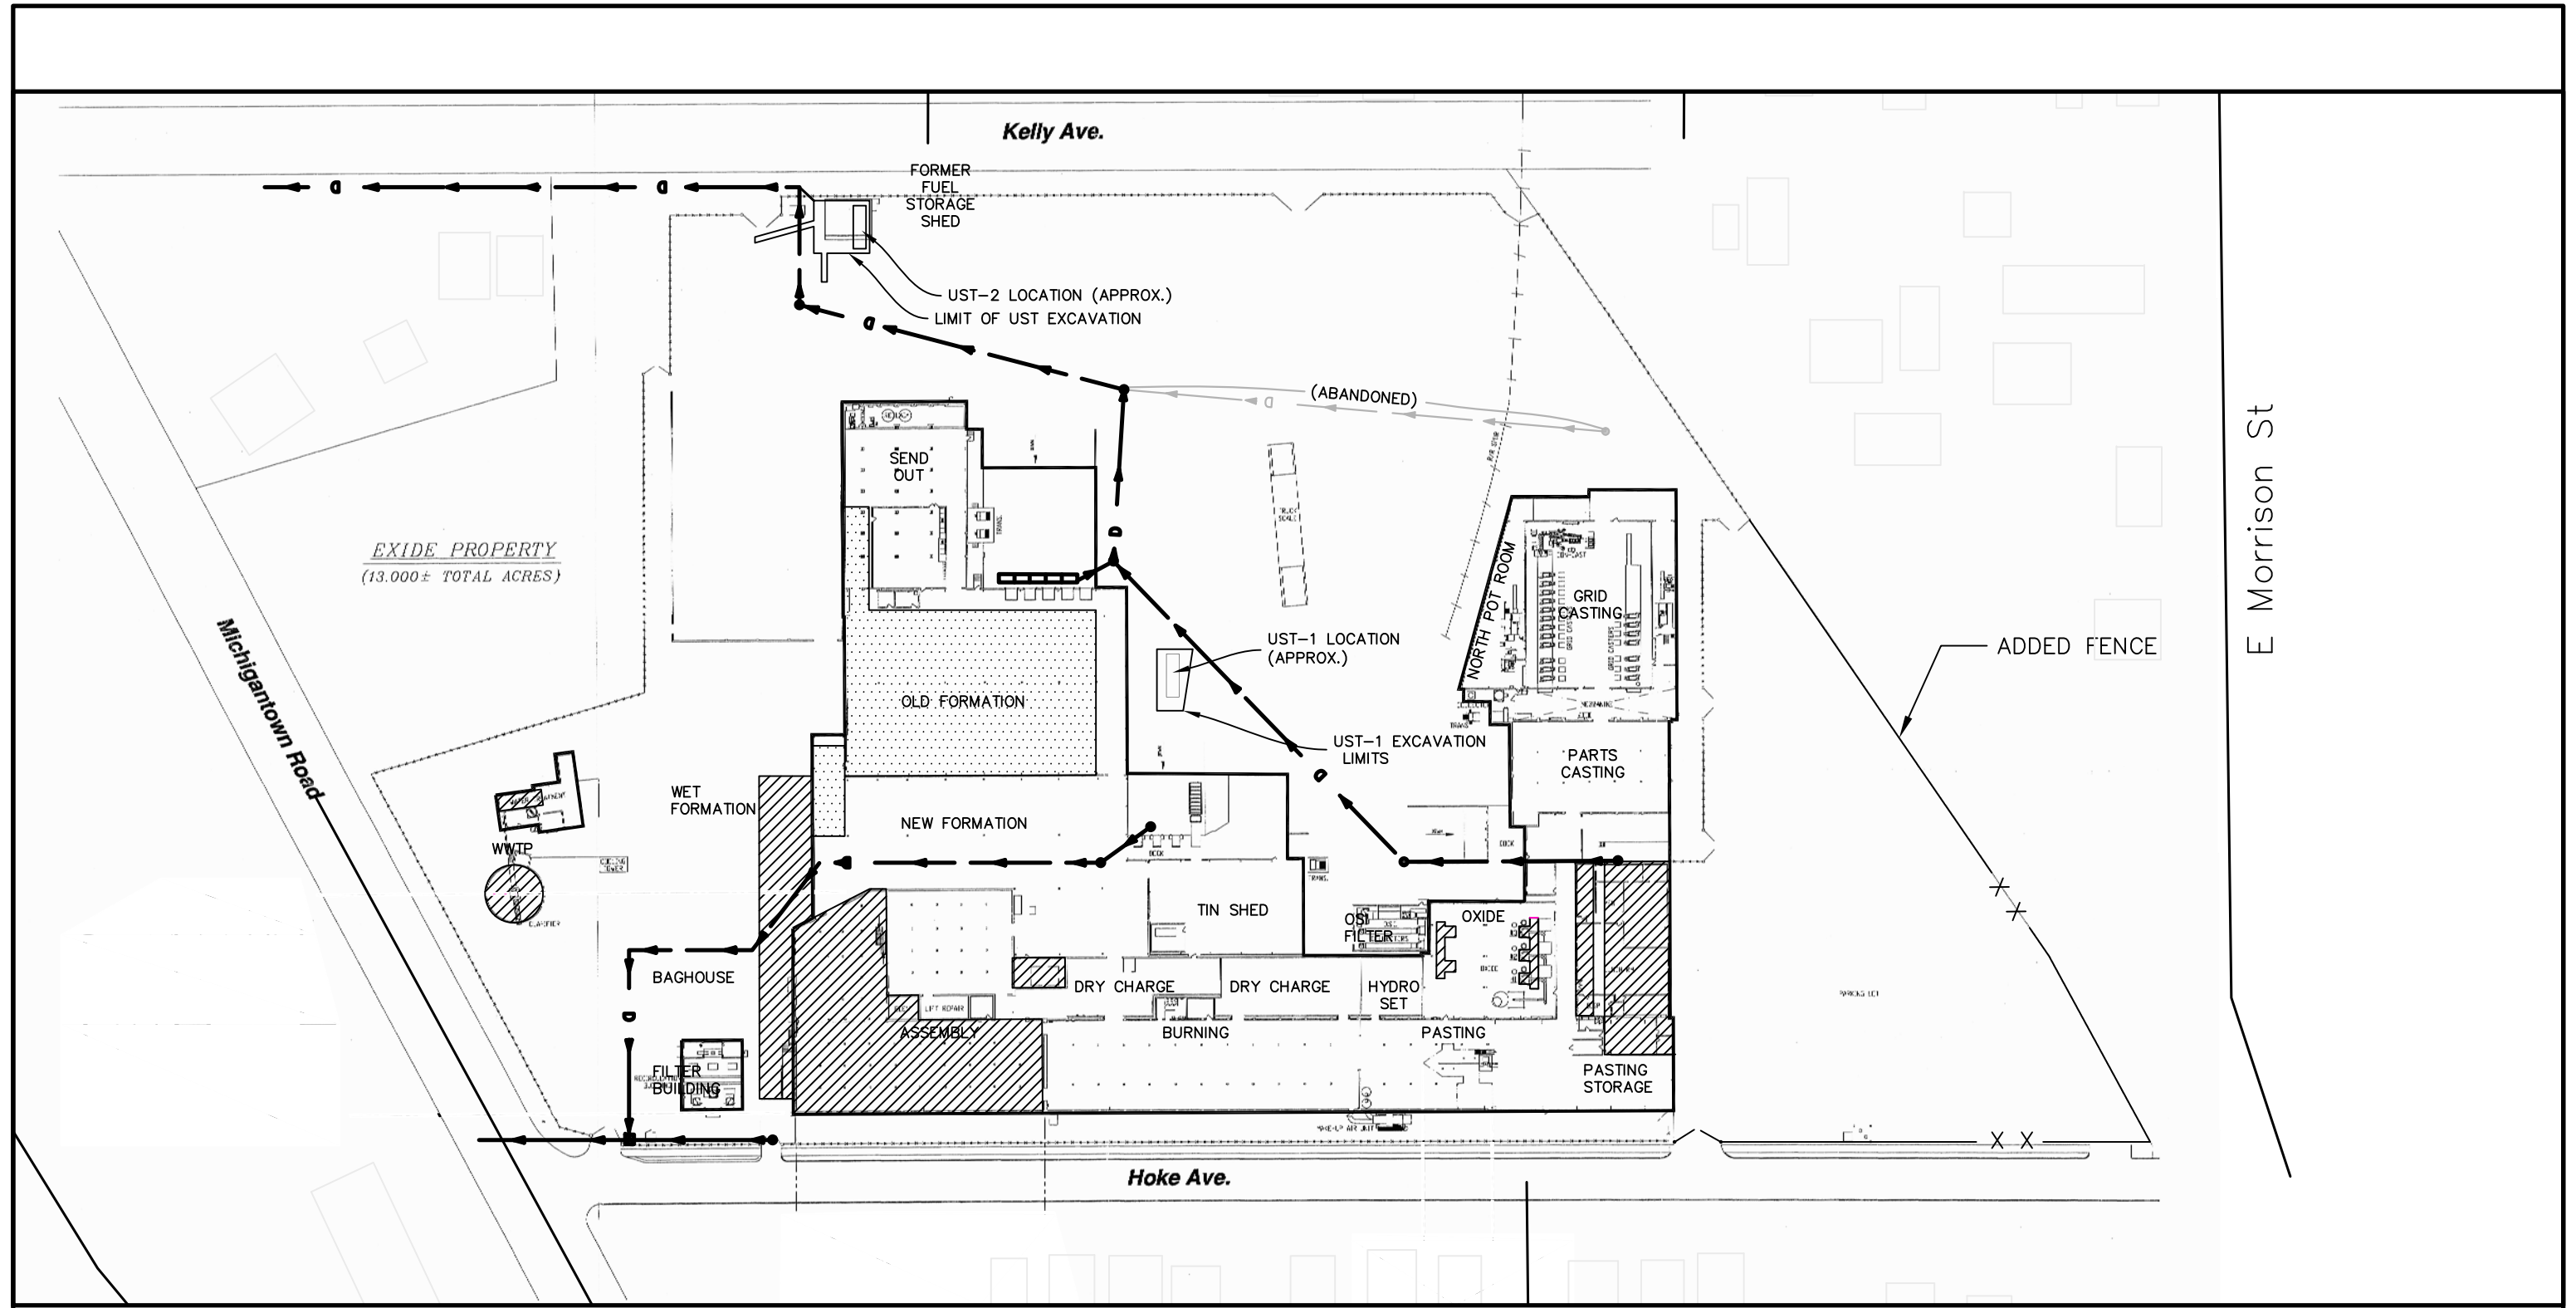
EXIDE TECHNOLOGIES 555 HOKE AVENUE FRANKFORT, INDIANA																			
POST-DEMOLITION CONDITIONS 2014																			
 Engineering for the Environment. Planning for People. 1055 ANDREW DRIVE, SUITE A WEST CHESTER, PENNSYLVANIA 19380 Tel: 610.840.9100 Fax: 610.840.9199 Web: www.advancedgeoservices.com

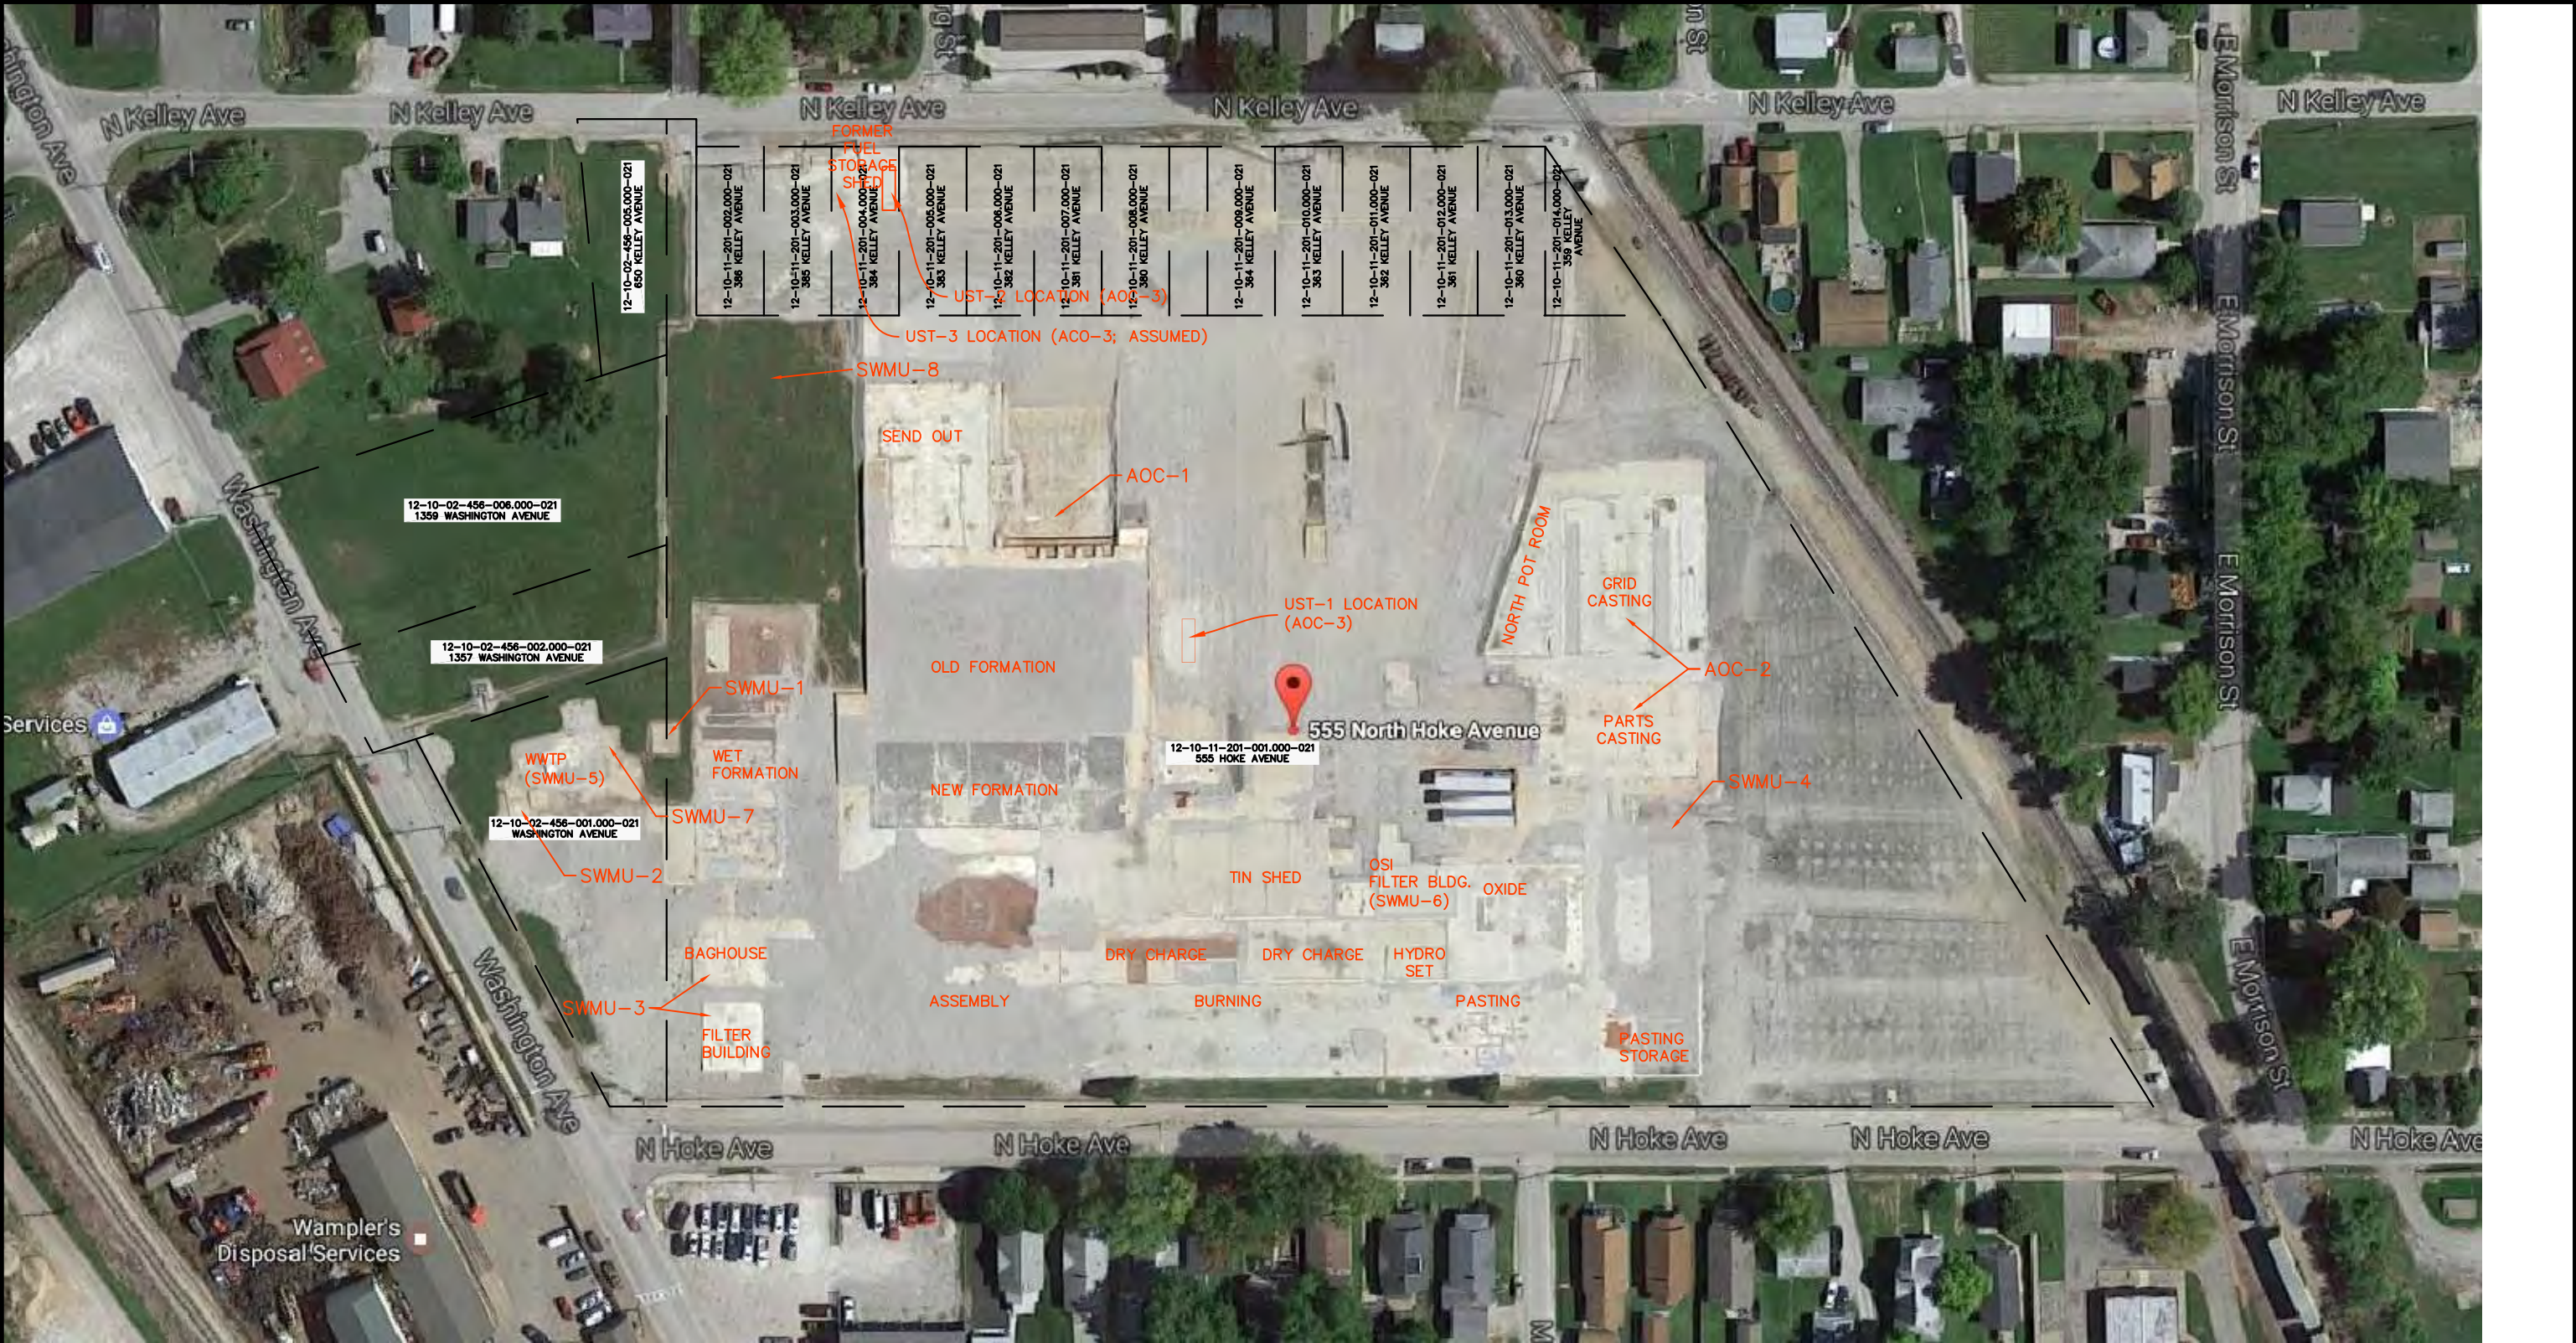
FIGURE 4

**CURRENT CONDITIONS 2017
SWMU AND AOC LOCATIONS**

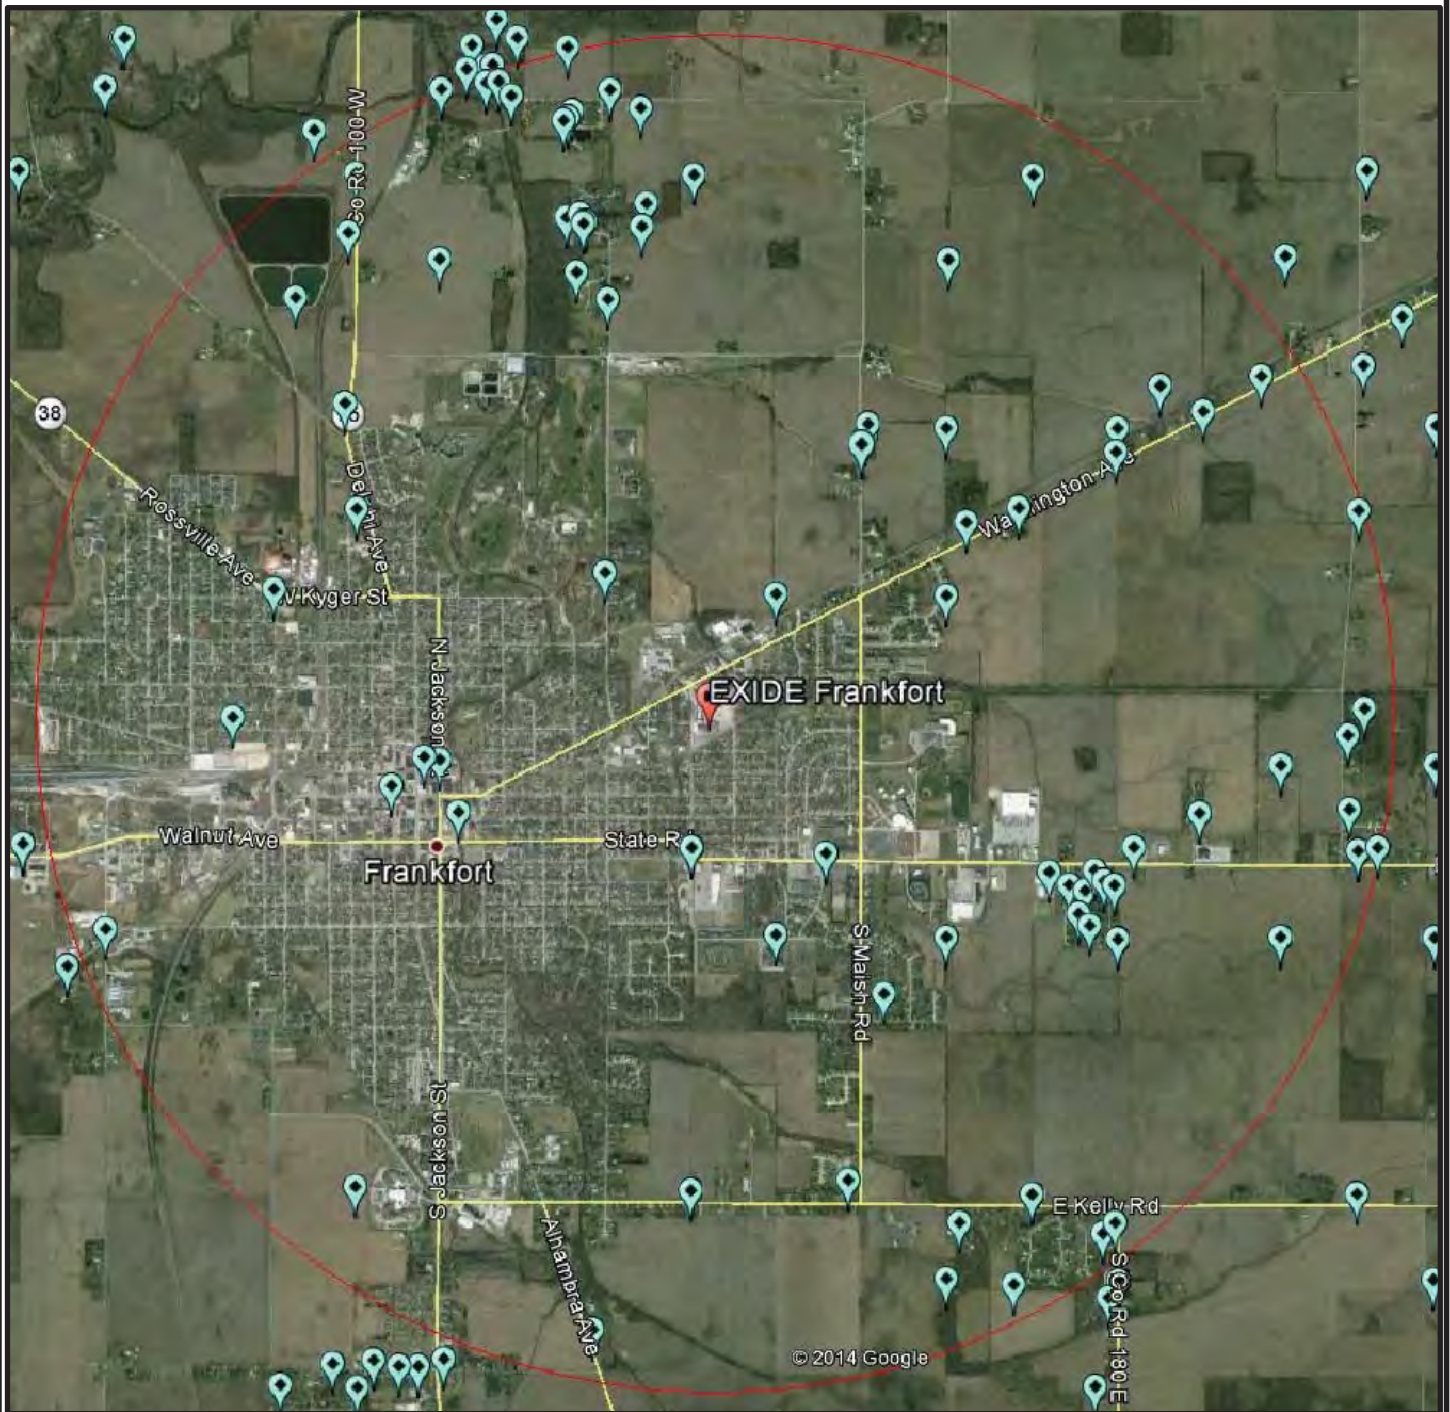
PROJECT ENGINEER:	PGS	SCALE:	NTS
CHECKED BY:	JSD	PROJECT NUMBER:	2011-2678
DRAWN BY:	KEZ	DATE:	7/21/14
		FIGURE:	7A

WELL LOCATIONS TAKEN FROM INDIANA DEPARTMENT OF
NATURAL RESOURCES – WATER WELL RECORD DATABASE

WELL SEARCH 2014
OVER 70 GPM & WITHIN 2 MILES
EXIDE TECHNOLOGIES
FRANKFORT, INDIANA

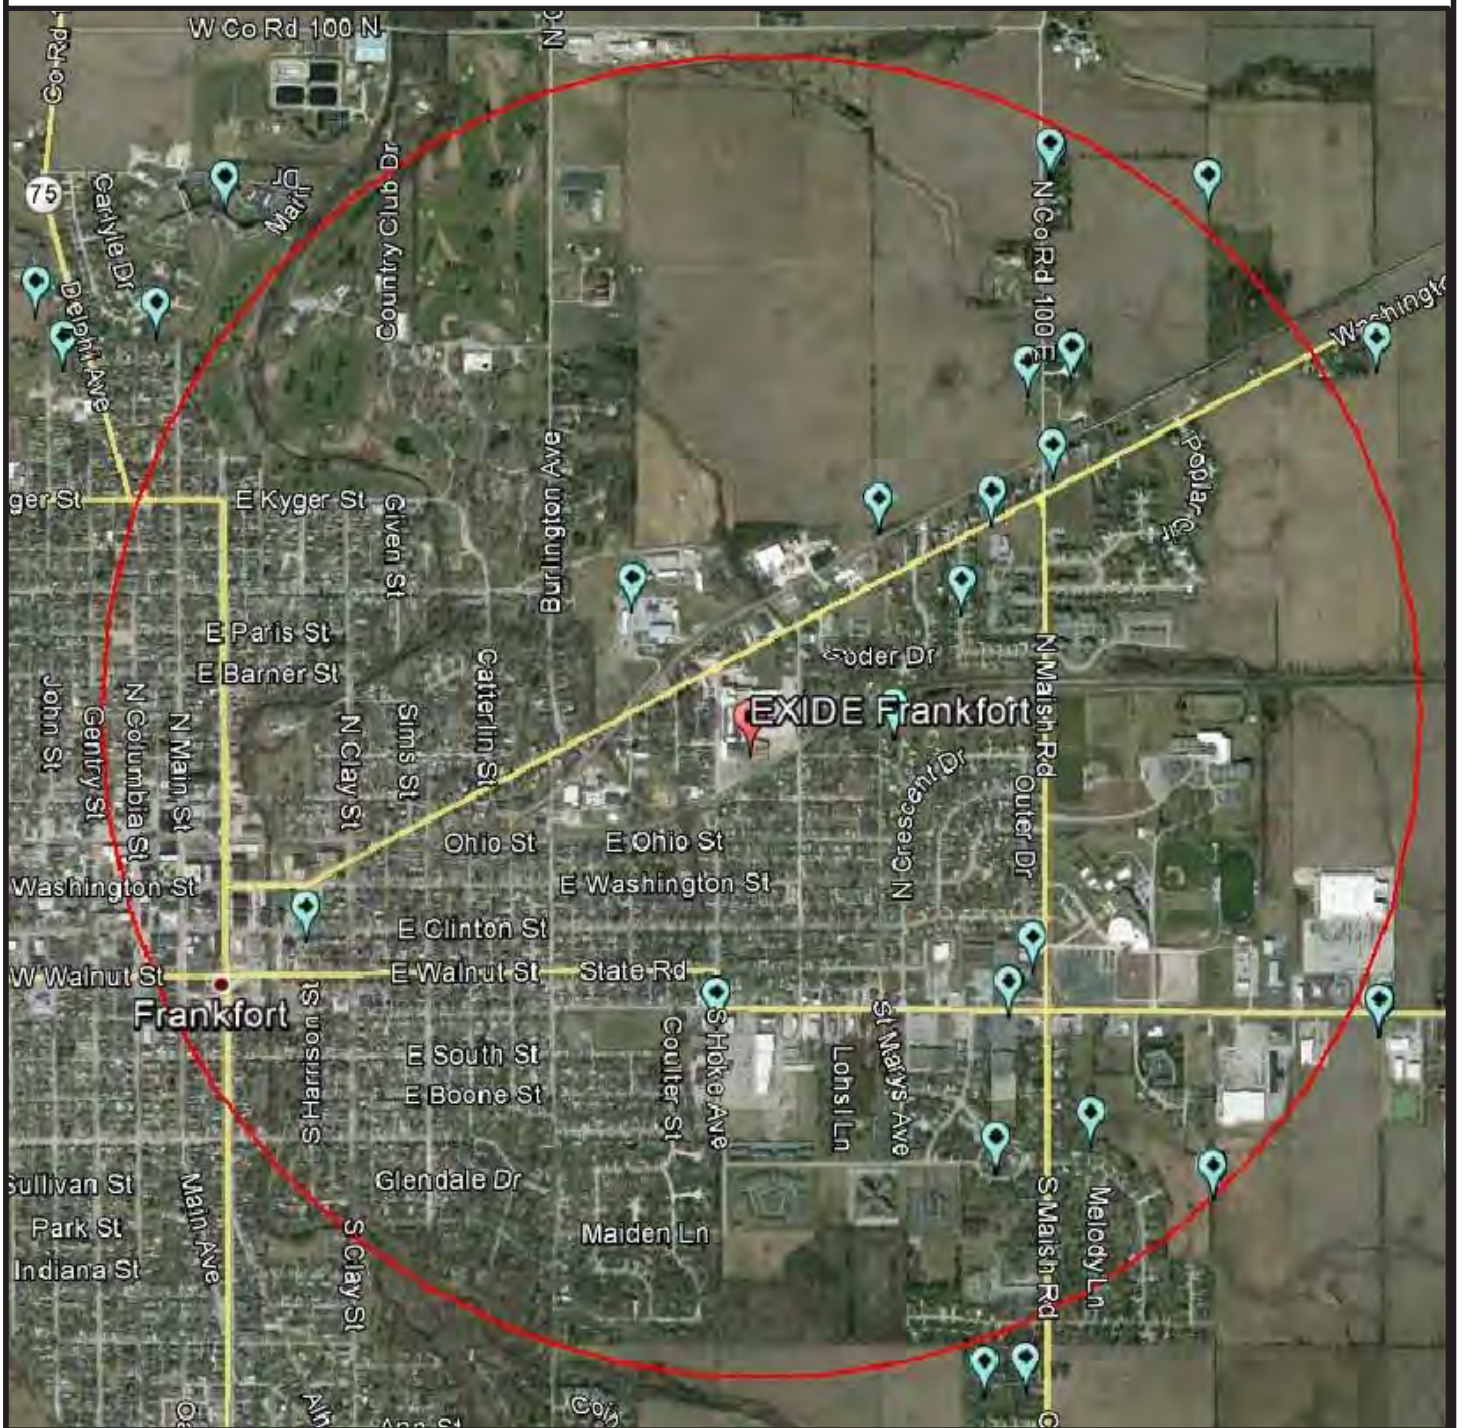
WELL LOCATIONS TAKEN FROM INDIANA DEPARTMENT OF
NATURAL RESOURCES – WATER WELL RECORD DATABASE

— 1 MILE RADIUS FROM SITE
